NF P01-013 Testing Report

Report Number KNFP010132103
Revision Number -

Name and definition of the sample : KE 100 -Railing

Procedure : NF P01-013:1998-08 Railings tests - Determination Of The
Mechanical Strength Under Distributed Static Loads and
Determination Of The Mechanical Strength Under Dynamic Loads

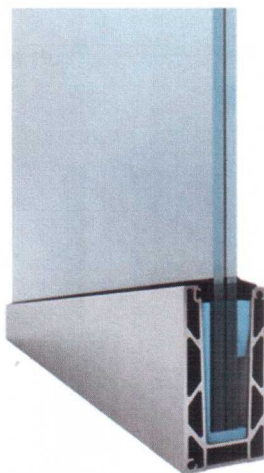
Sample schematic drawing of the product

The railing system consists of the parts listed below.
Total length:1000mm
Height:1200mm

MODEL – KE 100			
NO	DESCRIPTION OF GOODS	RAW MATERIALS	Quantity
1	10+1,52+10 mm GLASS	10+1.52+10 GRINDING + LAMINATED GLASS (1200 Height x 1000 Width x 21.52 Thickness)	2
2	8+1,52+8 mm GLASS	8+1.52+8 GRINDING + LAMINATED GLASS (1200 Height x 1000 Width x 17.52 Thickness)	2
3	6+1,52+6 mm GLASS	6+1.52+6 GRINDING + LAMINATED GLASS (1200 Height x 1000 Width x 13.52 Thickness)	2
4	KE 100 Balustrade Profile (1 Meter)	Aluminum 6063 T6	6
5	M10 Anchors	Total of 3 anchors for 1 meter with an interval of 300mm	18
6	Green Installation Plastics for 10+1,52+10 mm Glass	ABS HI121H Plastik mechanism to ensure the perpendicularity of glass.	8
7	Blue Installation Plastics for 8+1,52+8 mm Glass	ABS HI121H Plastik mechanism to ensure the perpendicularity of glass.	8
8	Red Installation Plastics for 6+1,52+6 mm Glass	ABS HI121H Plastik mechanism to ensure the perpendicularity of glass.	8
11	Compression and outside rubber	Total of 2 pieces (each one has a length of 1 meter) for each profile.	12

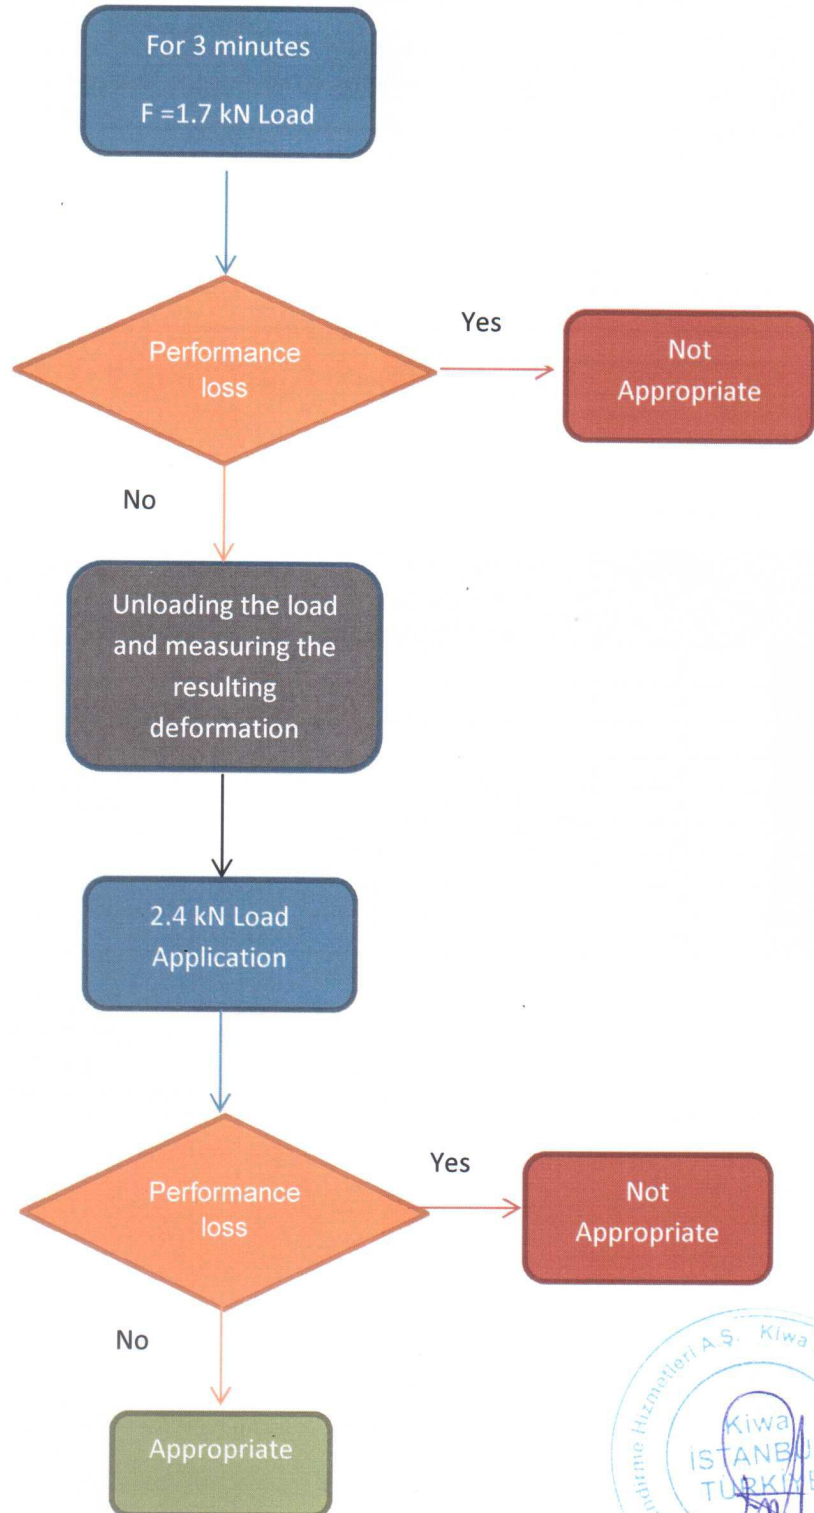
Test Flow Chart

As a step 1, 1700N/m load was applied to the product for 3 minutes as a preload. We observed changes in the product.

As a second step 2400N/m load was applied to the product. We observed changes in the product.

Verification of maximum permanent set "a" after removal of safety load using the following equation:
